Line 5 Comments

July 8, 2020

The League of Women Voters of Wisconsin (LWVWI) thanks you for this opportunity to comment on the EIS and waterways permitting processes related to the proposed construction of 41 new miles of Line 5 through the Bad River Watershed. We have many concerns about the impacts the construction, maintenance, and operation of the pipeline would have on the environment, public safety, and emergency response capacity.

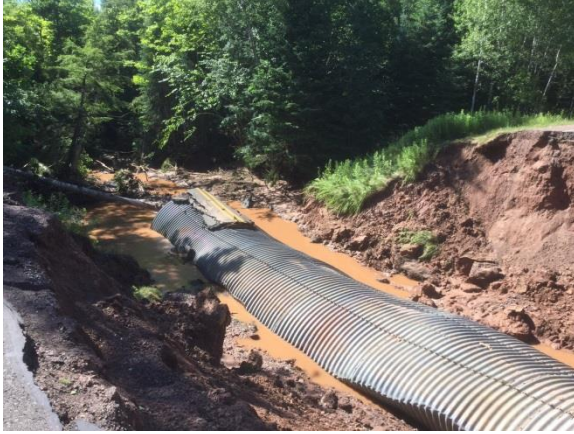
Vaughn Creek on Hwy 169, Iron County, July 12, 2016.

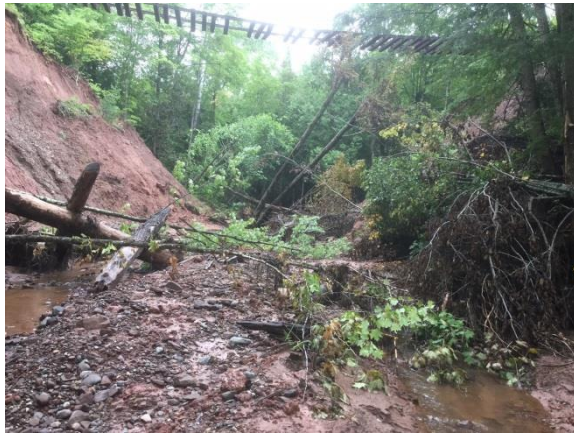
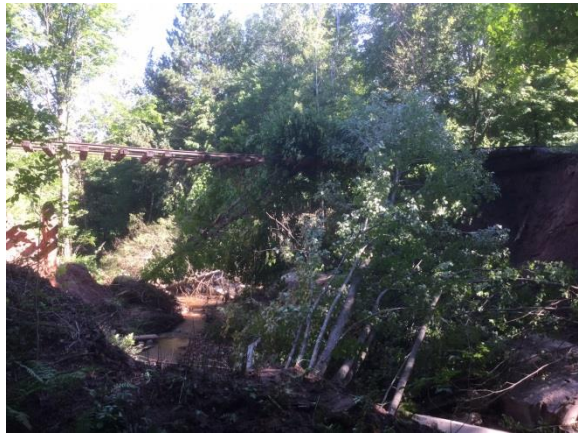
Railroad crossings over two small unnamed tributaries, Iron County, July 2016.

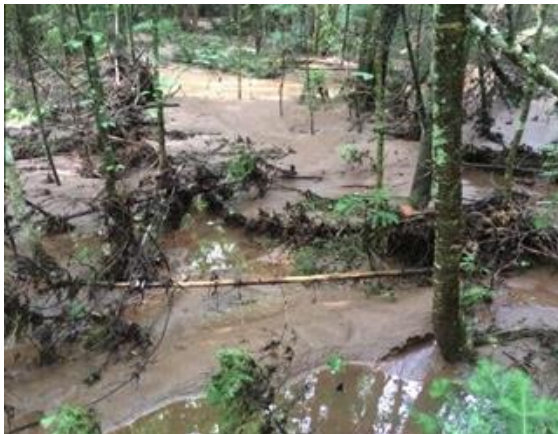
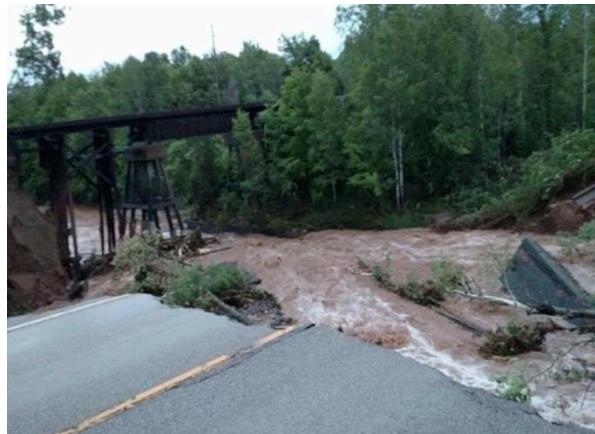
Billy Creek (left) and Trout Brook (right), Ashland County, July 2016.

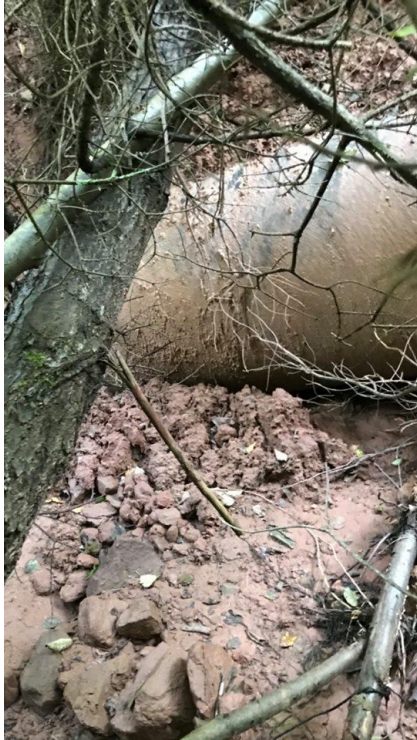
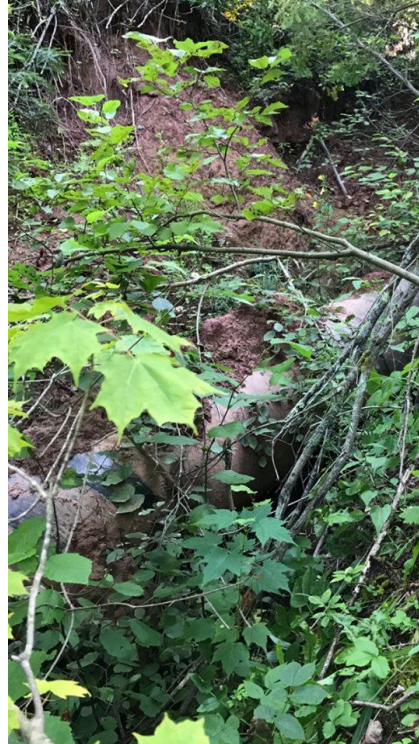
Enbridge engineers have evidently not yet found a way to remedy the exposed pipe on the existing line on the Bad River reservation. These photos, taken by a Bad River tribal member, shows Enbridge Line 5 pipeline uncovered by erosion on the reservation.
